Identifying and Cataloging Water Pollution Sources by Watershed Using Aerial Thermal Infrared Imaging and GIS

Sewickley Creek Watershed

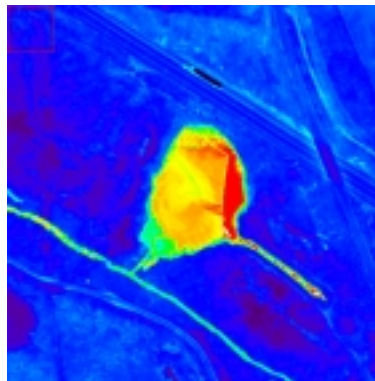
Enhanced Colormapped Image

Image Histogram Stretch

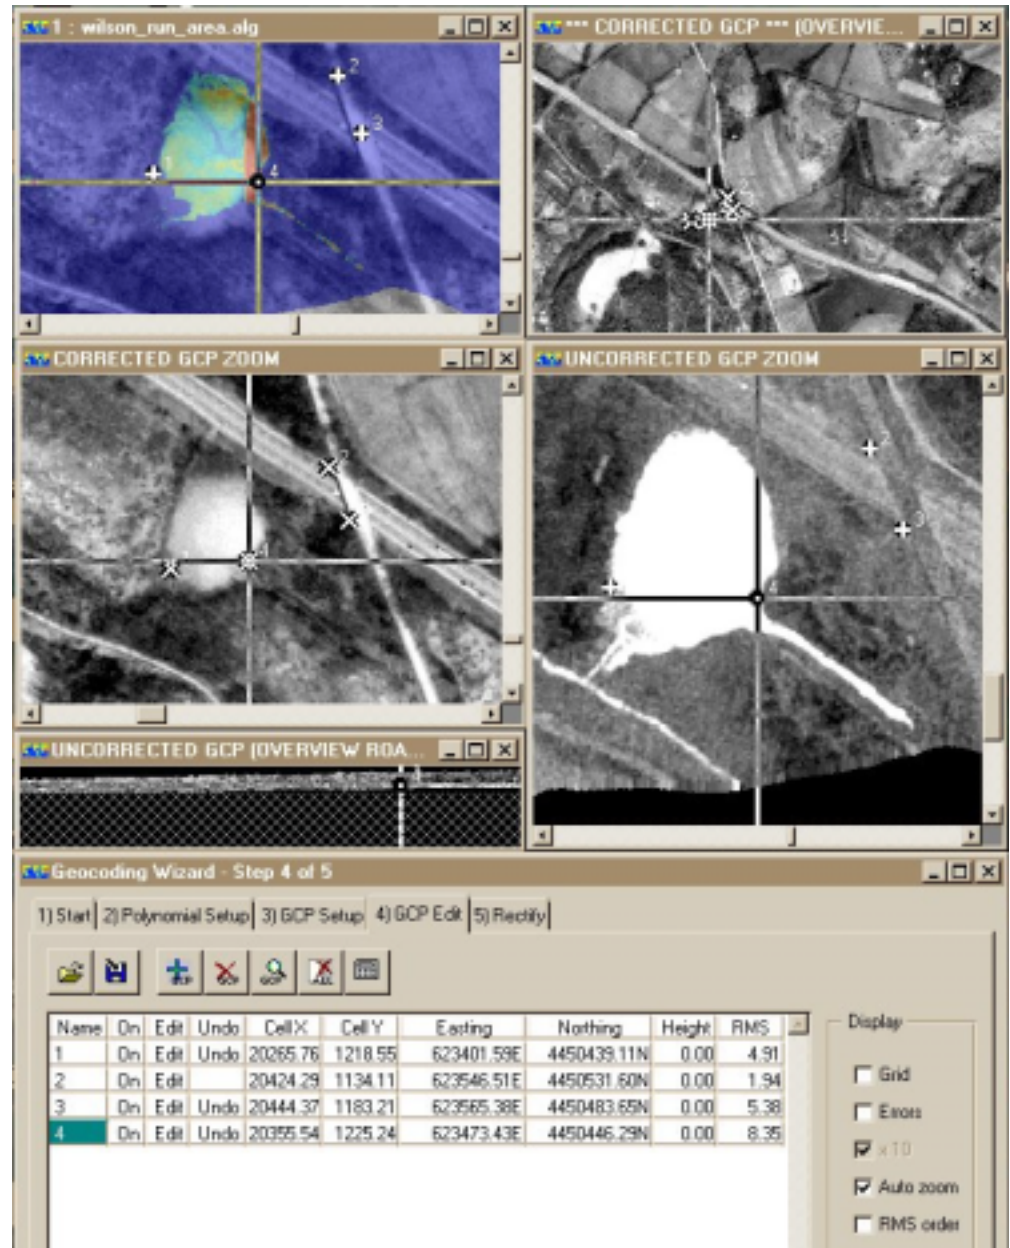
Polynomial Image Rectification

Ground Control Point (GCP) pairs are selected from reference map/image and corresponding locations on uncorrected image

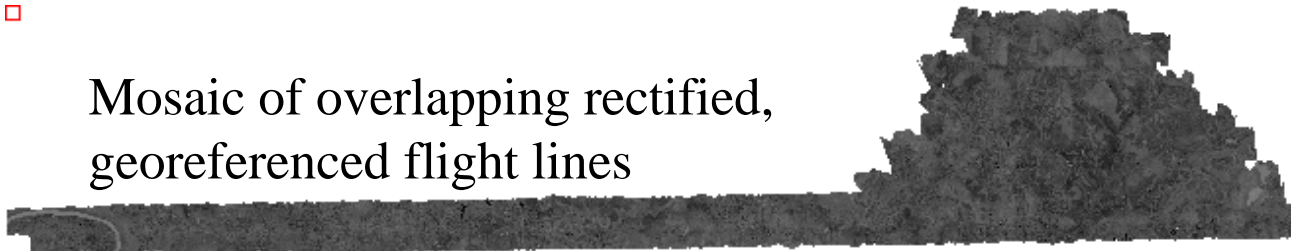
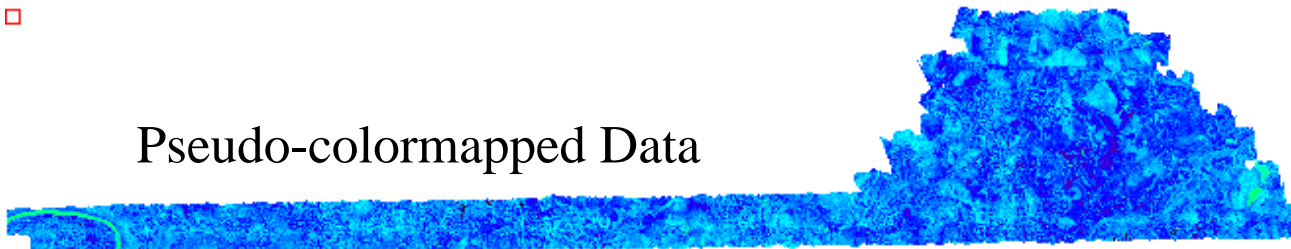
Processing Imagery Data

Single georeferenced and rectified flight line

Colormapping
Algorithm

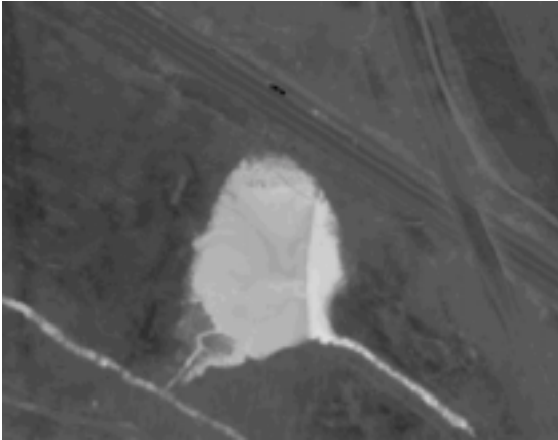
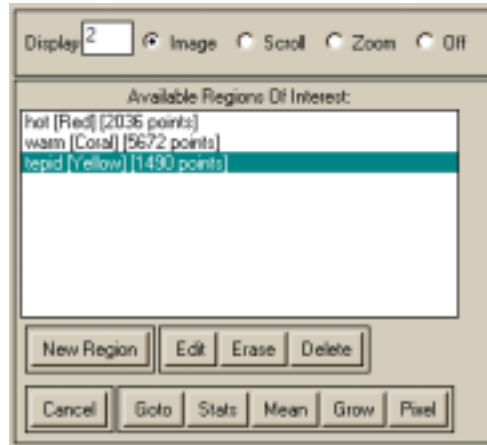
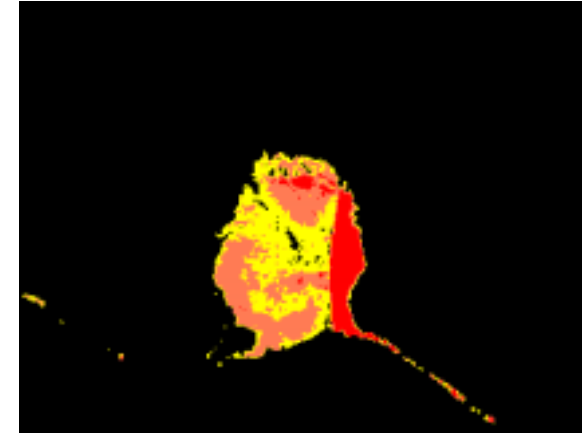
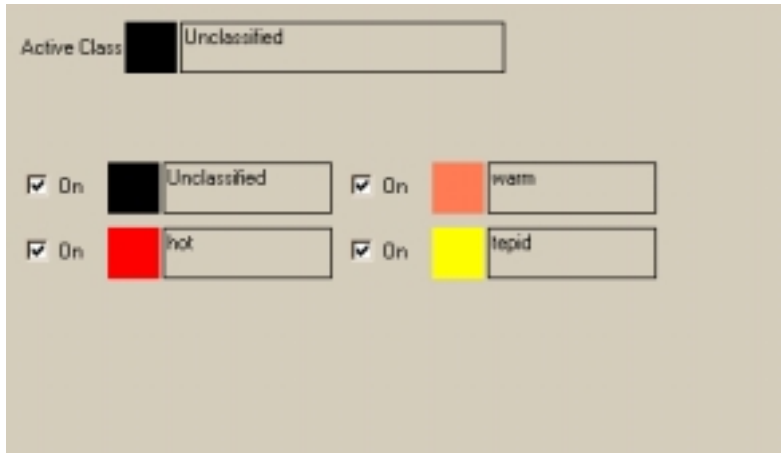
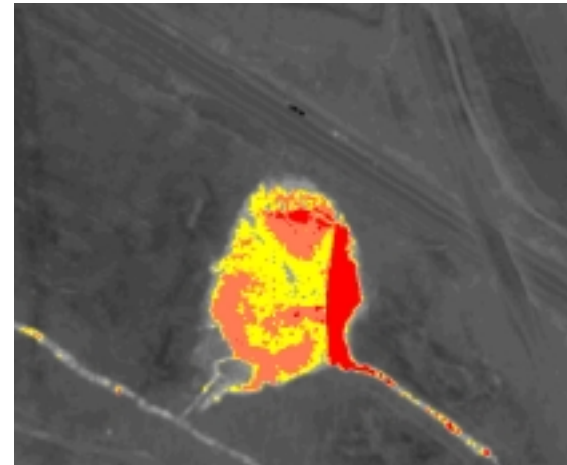
Supervised Image Classification

Unclassified Image

Define Training ROIs

Classification Layers

Classification Overlay

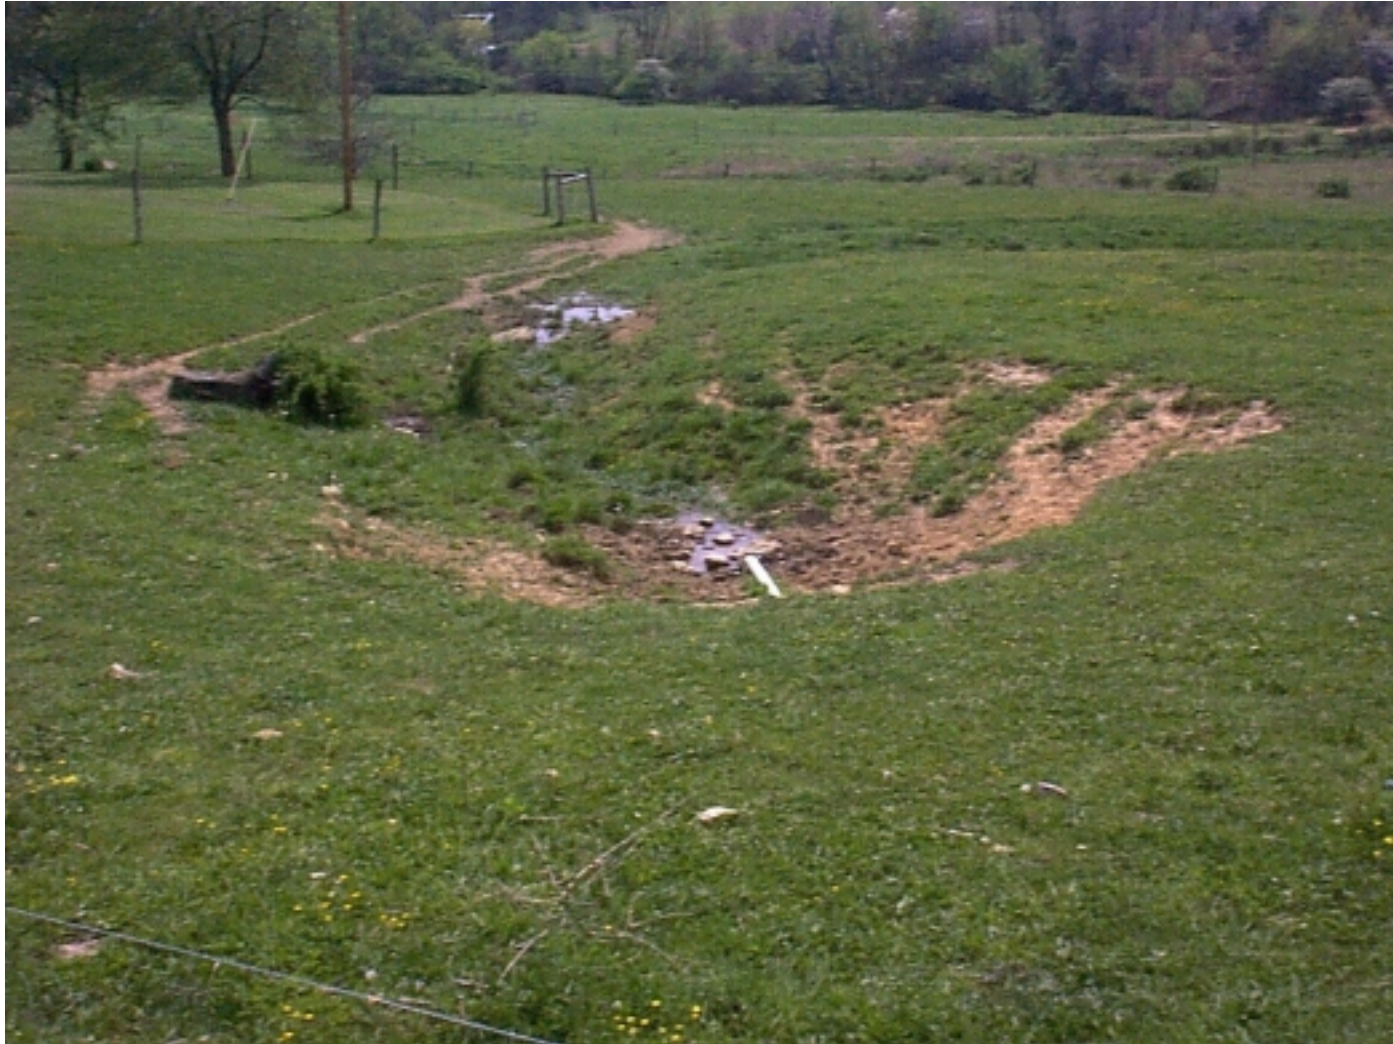
Possible graywater discharge located during field reconnaissance
